# Manhole Inspection Summary

Manhole # S37U1\_013MH

**Location** Address: **3442 2nd St**

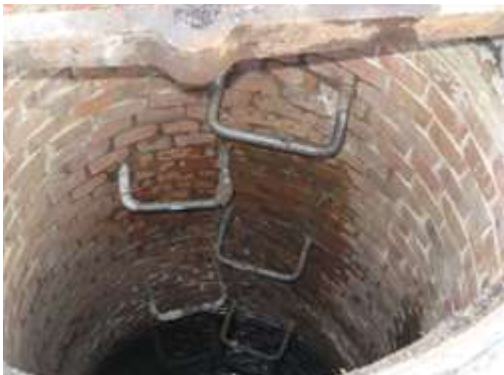
Steps

Count: **6** Missing: **0** ☐ Corroded

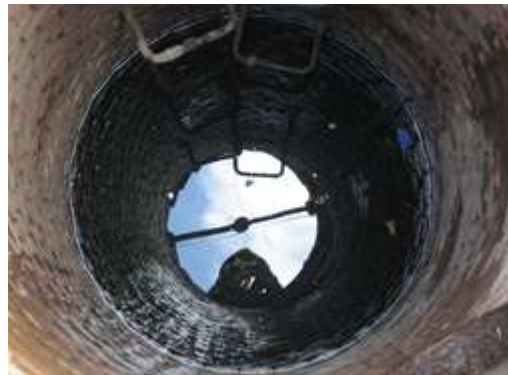
Defect 2

☒ **Evidence Of Surcharge** Depth: **3** (ft.) ☒ **Active Surcharge Present**

Active surcharge

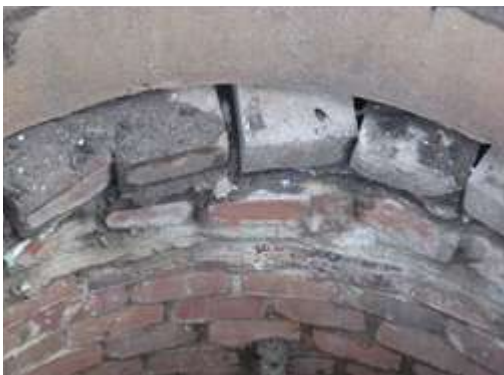
Defect 1

Condition: ☐ Sound ☐ Cracked ☐ Root Intrusion ☒ **Loose Brick** ☐ Deteriorated

Infiltration: ☐ None ☒ **Joint** ☐ Cracks ☐ Mortar ☐ Roots ☐ Wall

Chimney

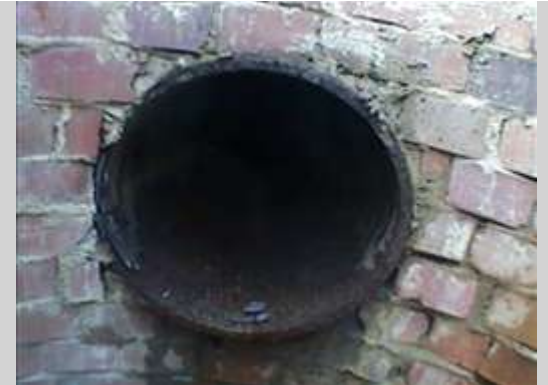
12 O'Clock Outflow

12 in. Circular Gravity Sewer  
Pipe Out @ 12 O'Clock
